Validation of Installation Methods for CSST Gas Piping to Mitigate Lightning Related Damage

Phase 1

Final Report

SEFTIM

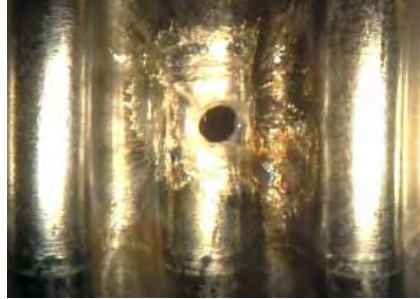
Example of Arcing Damage observed after the Test

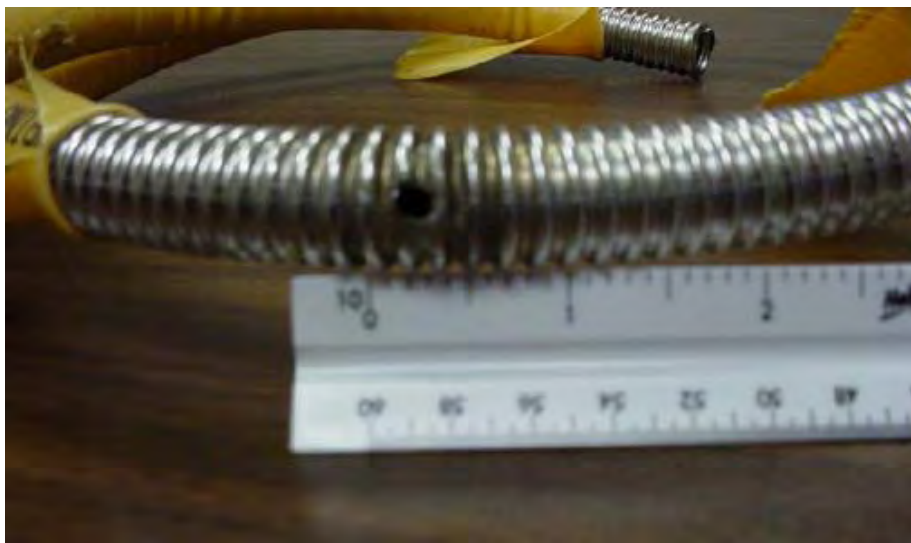
Damage caused by a lightning strike to a CSST system can be described as small puncture of the tubing wall. This type of damage is caused by an arc of energy “jumping” from a pathway of higher potential to a pathway of lower potential in an effort to find a lower impedance pathway to ground. This type of damage appears to be consistent around the country.

Example of Damage to CSST

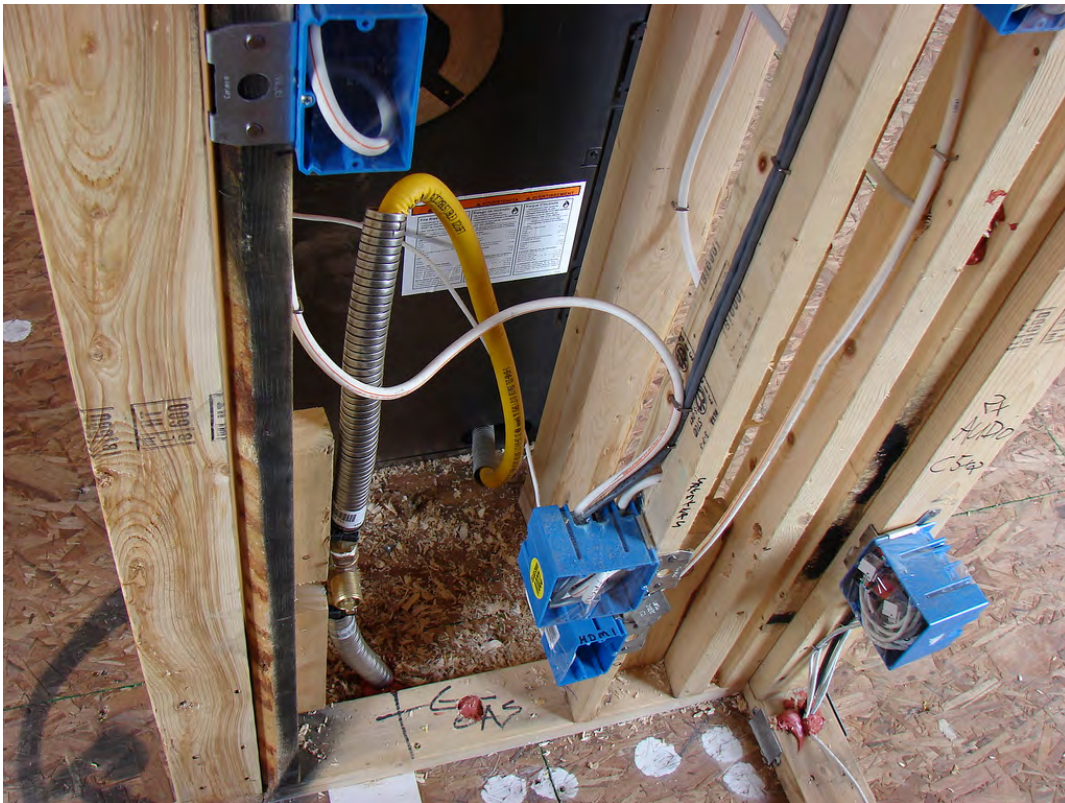
CSST is run Outside a Metal Tube for a Short Distance

This installation doesn't seem to be a general practice. This is an installation in Indiana. Upon inspection the gas company said that by Indiana code, the CAT5 cables must be greater than 2" away from all yellow CSST gas line. The interface between metal tubing and CSST is probably at high risk. A manufacturer pointed out that the bend radius was smaller than the minimum bend radius which was specified in the manufacturer's installation instructions.

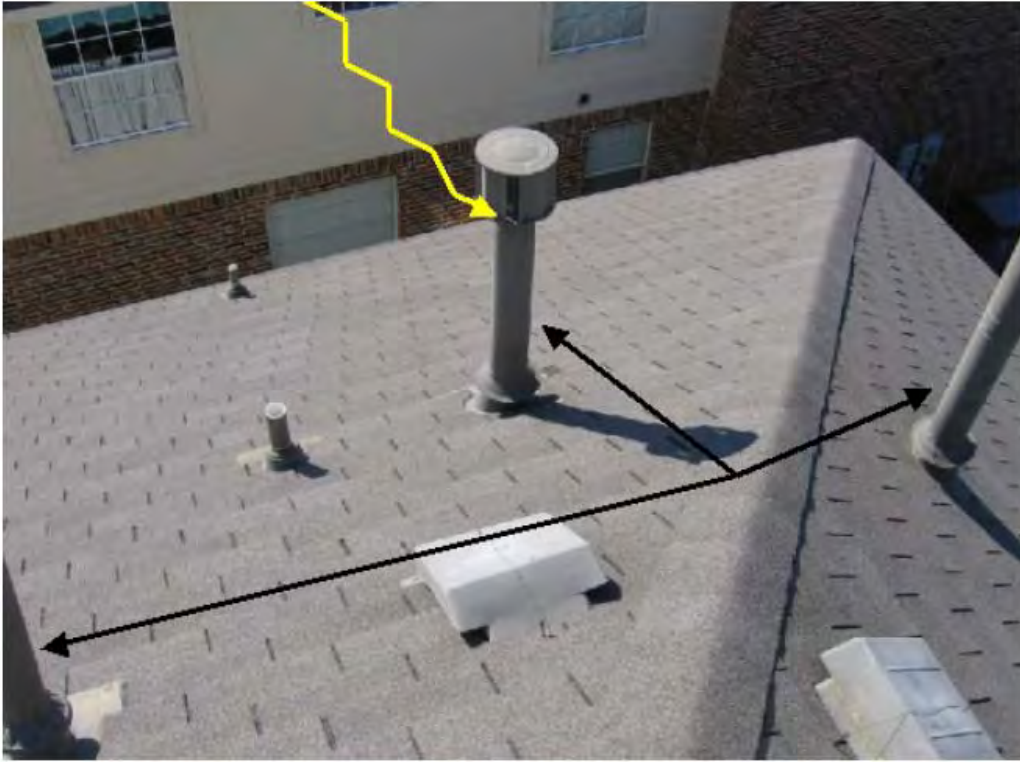
View of the Metal Flue Pipes on a Roof

The metal flue pipes shown in this photo may act as the preliminary lightning attachment point in the case of lightning strike on the roof; thus, significant lightning current may be flowing through CSST.

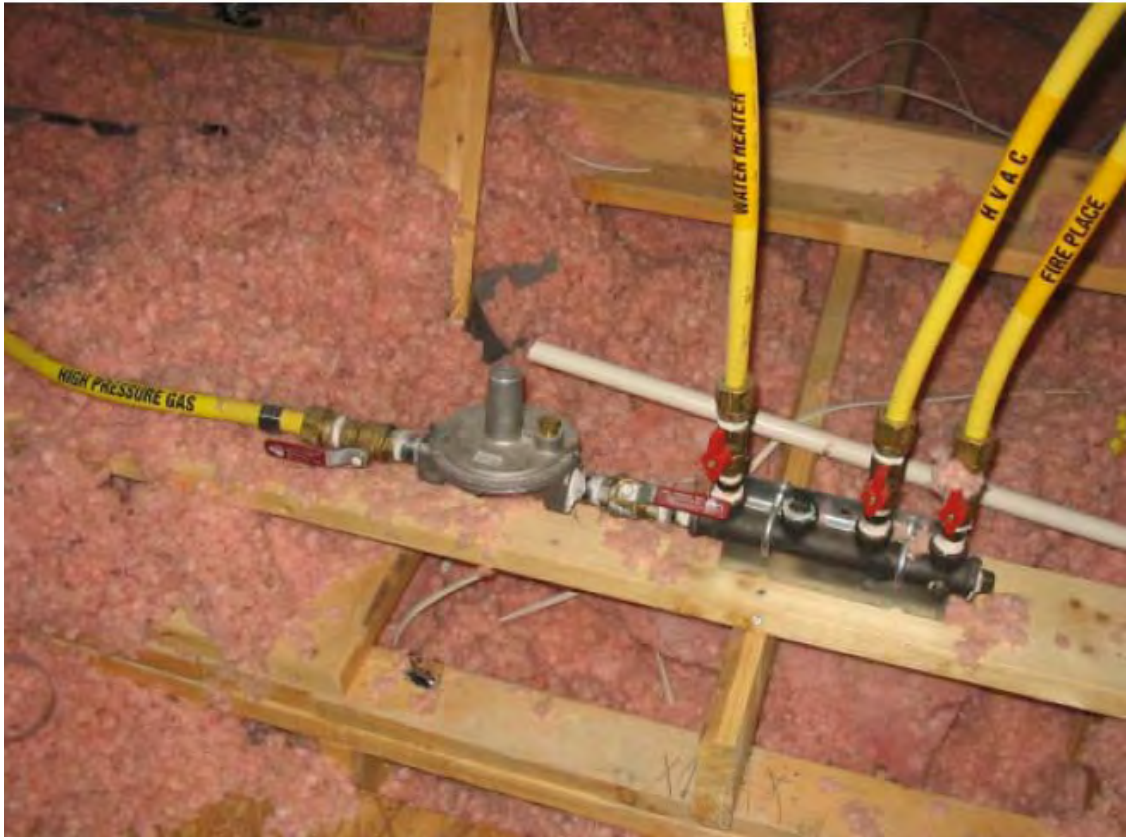
Attic CSST Installation without Visible Bonding

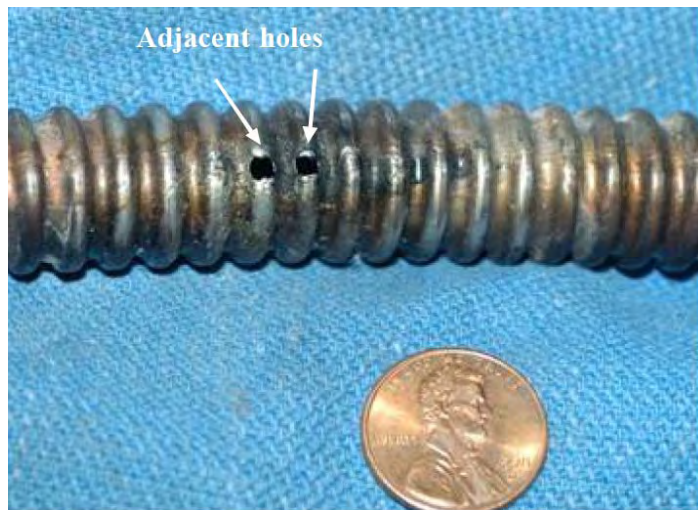
Name of file:	p379 Goodson gasoline and lightning .pdf
Title:	LIGHTNING INDUCED CSST FIRES/FIRE AND MATERIALS 2005 31st January - 1st February 2005 Fisherman's Wharf, San Francisco USA
Author:	Mark E Goodson
Date of publication:	February 1, 2005
Place of event:	?
Date of event:	< October, 2004
Direct strike?	?
CSST bonded?	?
Electrical lines involved?	?
Comment	Good example of multiple holes on CSST.

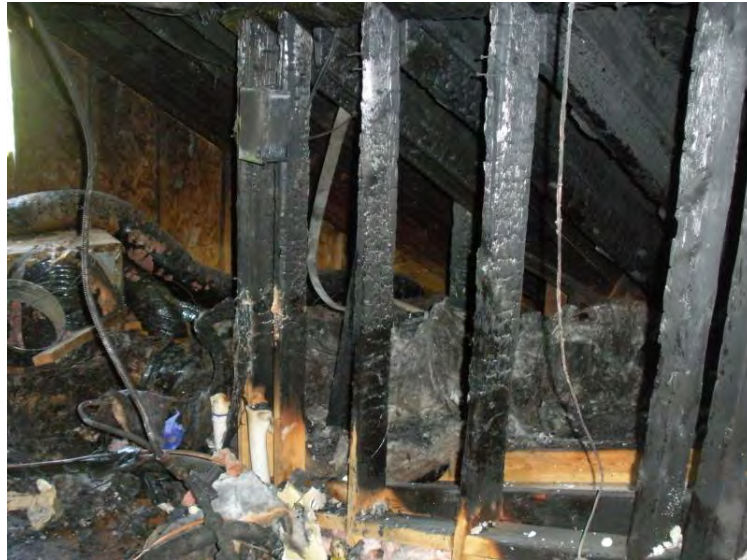
Name of the file:	csstlightning (2).docx + private communication
Title:	Is There a Lightning Induced Fire Hazard In Bedford?
Author:	Multiple authors including Mitch Guthrie
Date of publication:	September 16, 2010
Place of event:	Raleigh, North Carolina
Date of event:	July 20 ^t , 2010, at about 7:00pm
Direct strike?	Yes
CSST bonded?	Yes
Electrical lines involved?	No
Comment	Multiple holes from direct lightning.

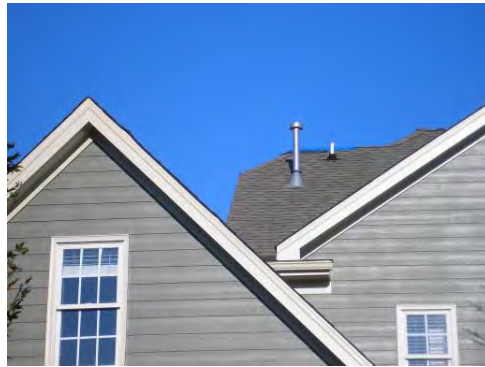
the homeowners, there was some apparent fusing at screws connecting the vent pipe to the water heater at the top and between the feet and a metal catch pan at the bottom of the water heater. Two damaged sections of CSST had been removed by the insurance company but the homeowner said both had multiple holes: one running between the water heater and the furnace (approximately 13 feet long with around 10 holes) and the other one running from the water heater to the dryer (approximately 18 feet long with around 15 holes).

Probable Striking Point

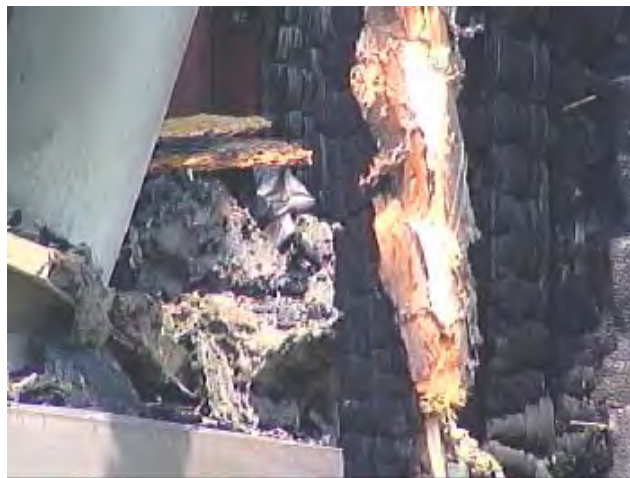
Name of file:	Gas Line a Factor in Fire that Destroyed HomeABC News 4.mht + private communication
Title:	Gas Line a Factor in Fire that Destroyed Home
Author:	ABC news + Mitch Guthrie
Date of publication:	July 20, 2009
Place of event:	Mount Pleasant, South Carolina
Date of event:	July 16, 2009
Direct strike?	Yes
CSST bonded?	Yes
Electrical lines involved?	Possible as the fire occurred as a result of a hole in CSST near a gas fireplace
Comment	Direct lightning strike. Damage in spite of bonding.

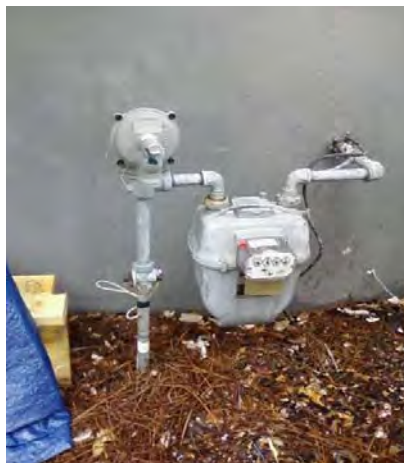
Gas Meter Bond

Grounding was present on the service entry at the meter. The measured soil resistivity was found to be 6.6 ohm-m, the measured resistance to earth of the incoming gas line was 1.8 ohms (both very good) and the bonding resistance between the electrical service ground and gas service entry was 0.82 ohms. The gas service entered the structure on one side while all other services entered on the other side. The fire occurred in a section of CSST located in the crawl space in the vicinity of the gas fire place approximately 12 feet from the bonding point at the service entry.

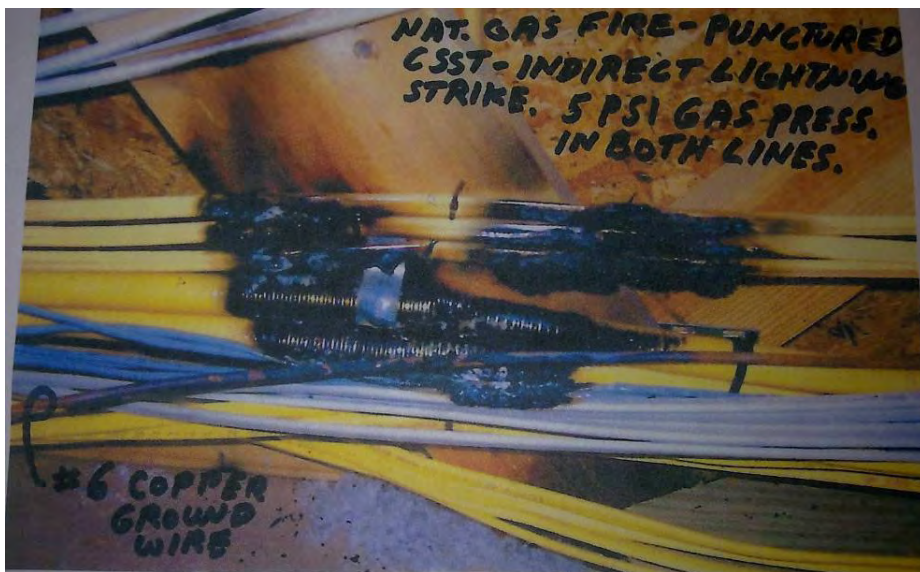
Name of file:	LPS CSST Incident May 2007.docx
Title:	CSST Lightning Incident
Author:	Private communication
Date of publication:	October 6, 2010
Place of event:	Florida
Date of event:	May 13, 2007
Direct strike?	No
CSST bonded?	Yes
Electrical lines involved?	No
Comment	CSST damage was close to the bonding conductor where it was running parallel with the CSST. Apparently flashover occurred between two CSST runs.

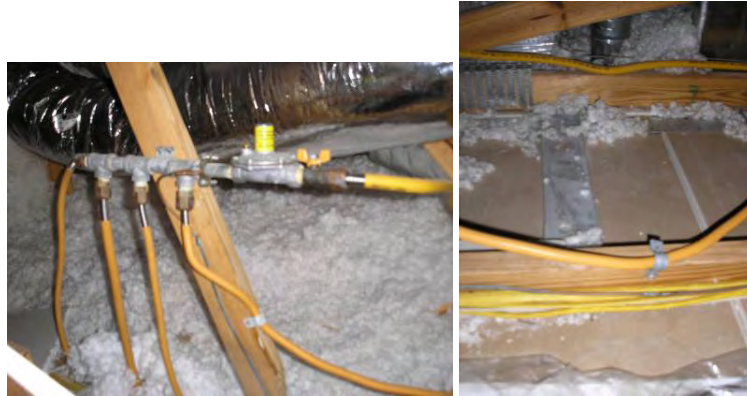
The NFIRS report indicates that there was a gas leak from a gas line in the attic and flame showing from the leak. The fire was extinguished by turning off gas.

Bonding Only at Manifold (left), and Location of Incident (right)

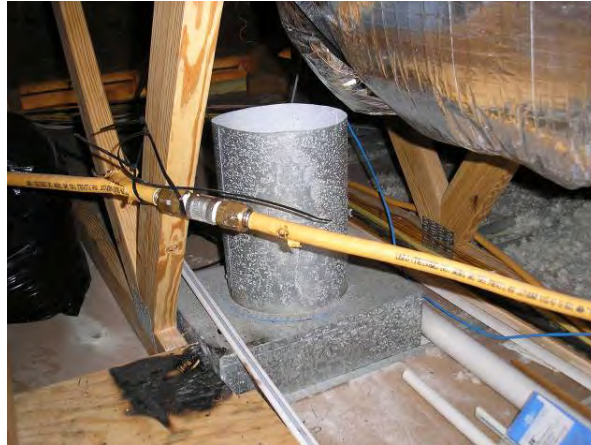
The NFIRS report indicates that a small 3" x 3" burned area was found with gas line plastic melted.

Place of Sparkover Between Metal Vent and CSST. (Note that CSST is now at distance from the initial position.)

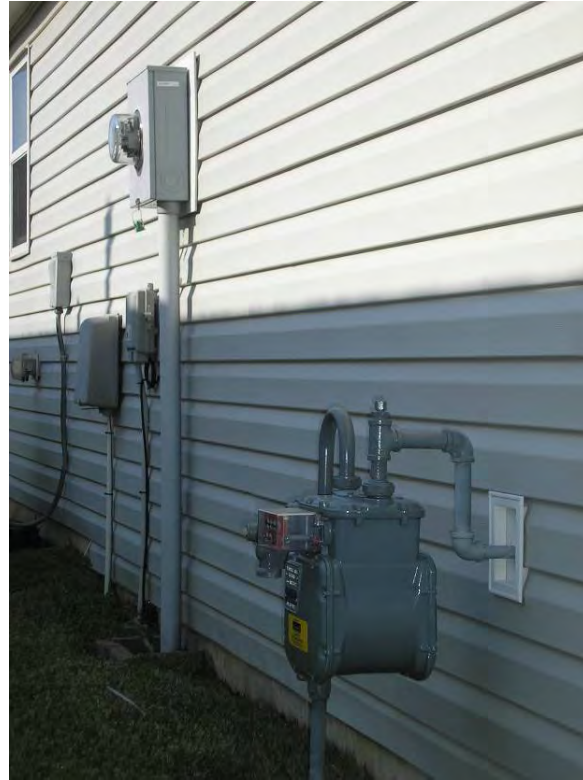
The figure below shows the relative location between the service entrances for the phone, electrical power, and gas. There was no visual evidence of an external bond between the gas service entry point and the electrical service ground.

Service Entry Locations for Electric, Gas, Phone, and Cable

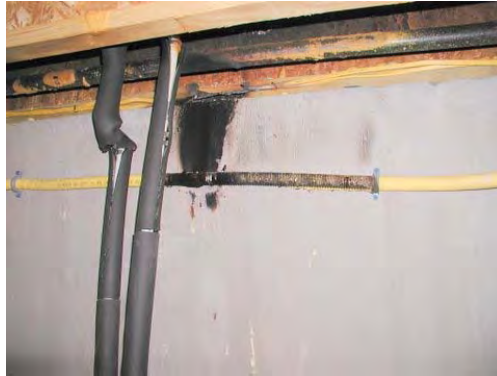
A radio tower is located nearby on top of the hill and is the nearest neighbor. This tower could have been the location of the lightning strike, but some people also mentioned a tree being damaged by lightning in the vicinity around the same time.

View of the Damaged CSST Near Two Vertical Plastic Pipes and Above CSST Electrical Cables, as well as a Metallic Pipe Run Horizontally

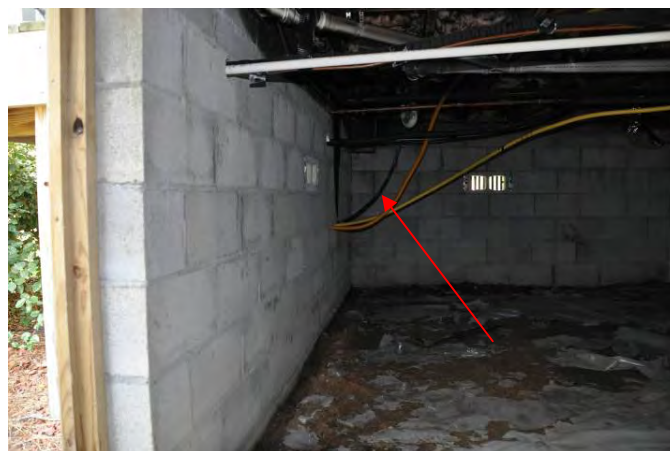
Damage can be seen on the CSST near a concrete block wall (no re-bar). The nearest metallic part is a copper water pipe located around 4 feet from the CSST holes (there are two holes on the CSST at the same location).

Location of CSST Hole Near the Wall

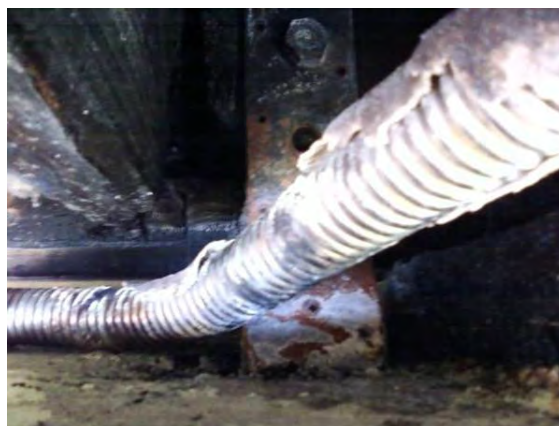
Location of the CSST Damage Near a Strap Connected through a Concrete Column to the House Basement

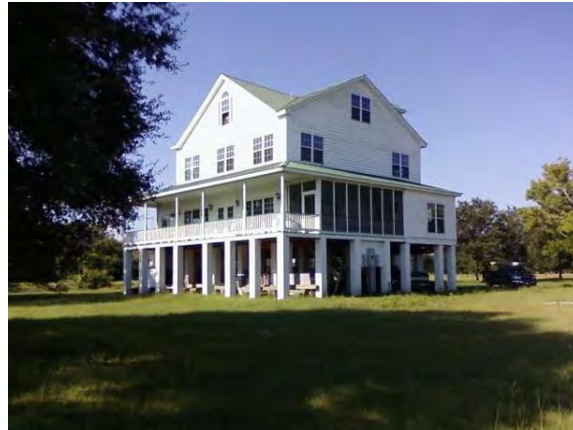
General View of the House Showing the Lack of Lightning Electromagnetic Shielding Provided by the Structure

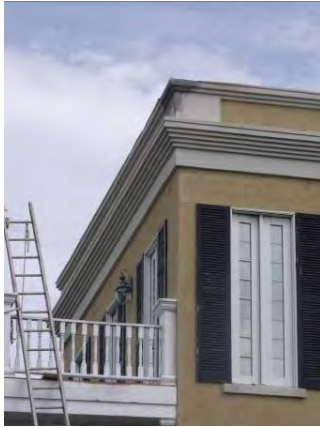
Direct Strike at Corner of Building
