Validation of Installation Methods for CSST Gas Piping to Mitigate Lightning Related Damage

Phase 1

Final Report

SEFTIM

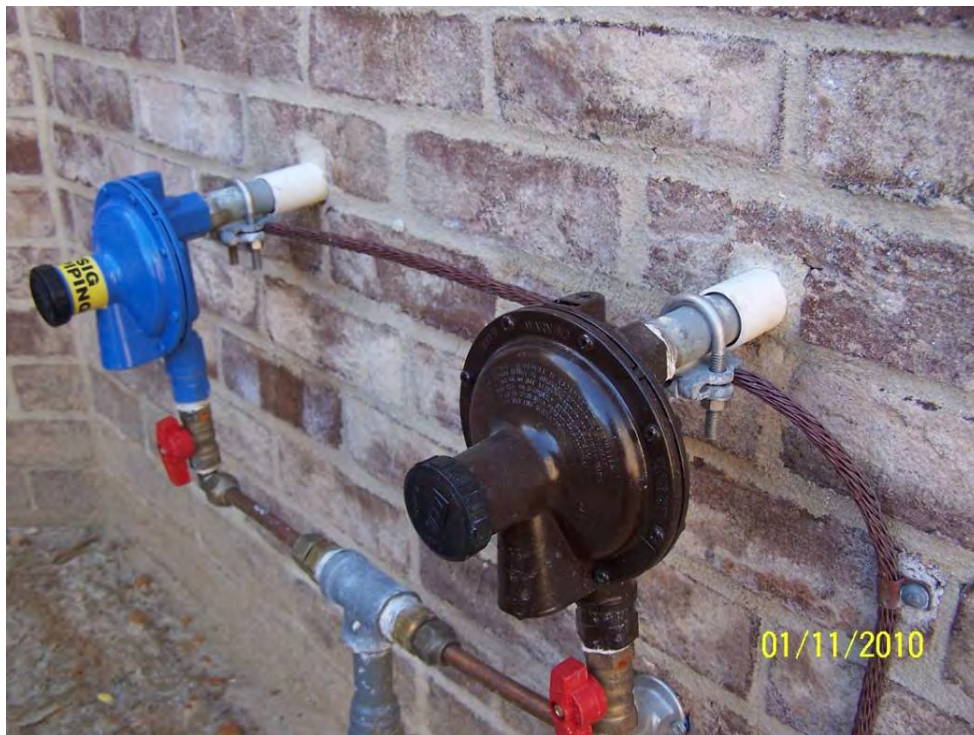
Bonding of Gas Pipe at Building Entrance

This installation doesn't seem to be a general practice. This is an installation in Indiana. Upon inspection the gas company said that by Indiana code, the CAT5 cables must be greater than 2" away from all yellow CSST gas line. The interface between metal tubing and CSST is probably at high risk. A manufacturer pointed out that the bend radius was smaller than the minimum bend radius which was specified in the manufacturer's installation instructions.

Note the size of the bonding conductor is bigger than #6 AWG, due to the fact that there is a lightning protection system installed per NFPA 780. It is interesting to note that in a few cases for which we have detailed description of installation, the bonding is made at the manifold only (sometimes in the attic), and not directly at the service entrance as shown in this figure and also as requested by the code.

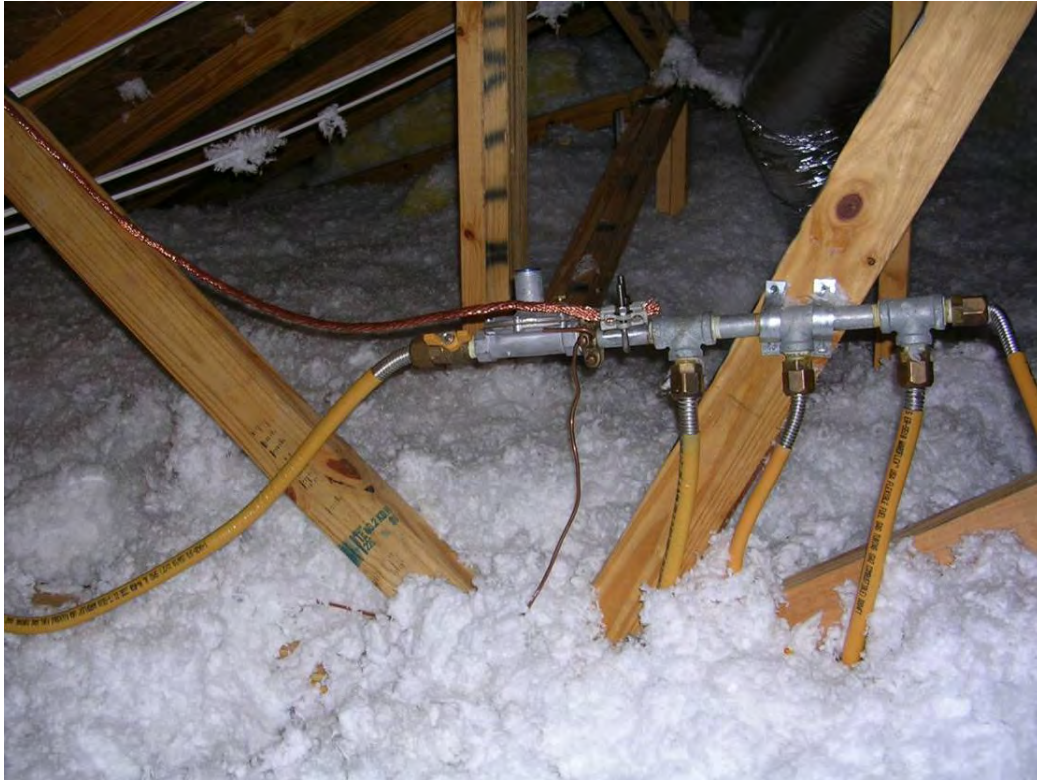
Grounded CSST Piping at Manifold

The CSST piping shown here is at the manifold with grounding provided by the CSST installer (small solid #6 AWG conductor) and the bond to the Lightning Protection System (main-sized conductor). Note that in this case the CCST bonding shown in the picture at the manifold in the attic is additional to the bonding at the entrance of the installation as required by NFPA 54.

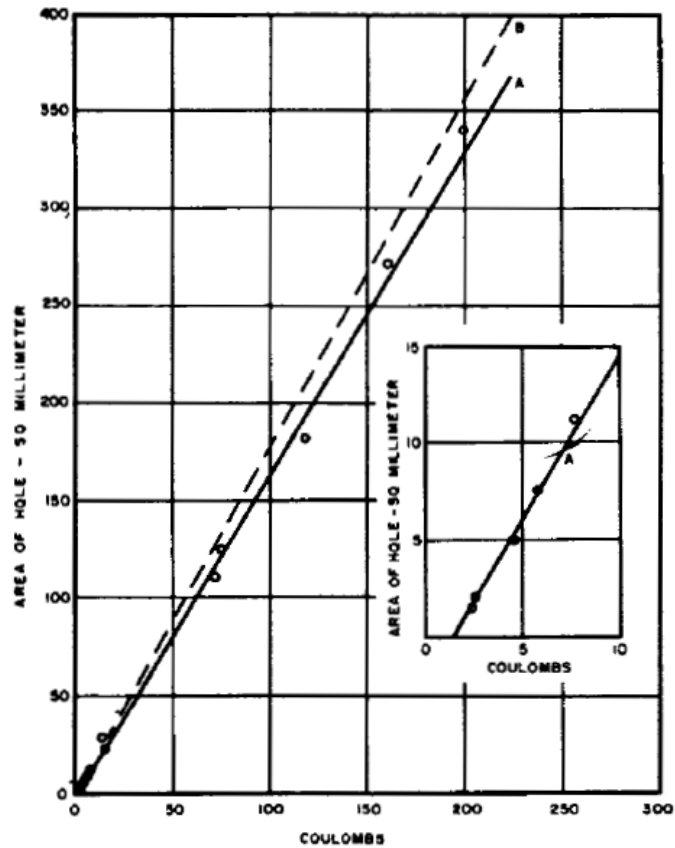
Impact on Metal Sheets (see [101])

The first damage that needs to be considered is effect of direct lightning impact on metal sheets. A paper from GE [101: [GE paper Effect of lightning on thin metal surfaces.pdf](#)] clearly explains that damages are more a consequence of the charge than of the magnitude of the current (continuing current of lightning instead of first impulse). The figure below gives the size of the holes for various values of current charge for a 15 mm galvanized iron sheet. CSST is thinner than this (less than 10 mm).

It is likely that any direct impact is not the cause of damage in the CSST incidents, but partial lightning might be. It is clear that, based on results from GE on thicker metal plates, even with relatively low values of charge associated with partial lightning currents, holes may be created on a thin sheet of steel.

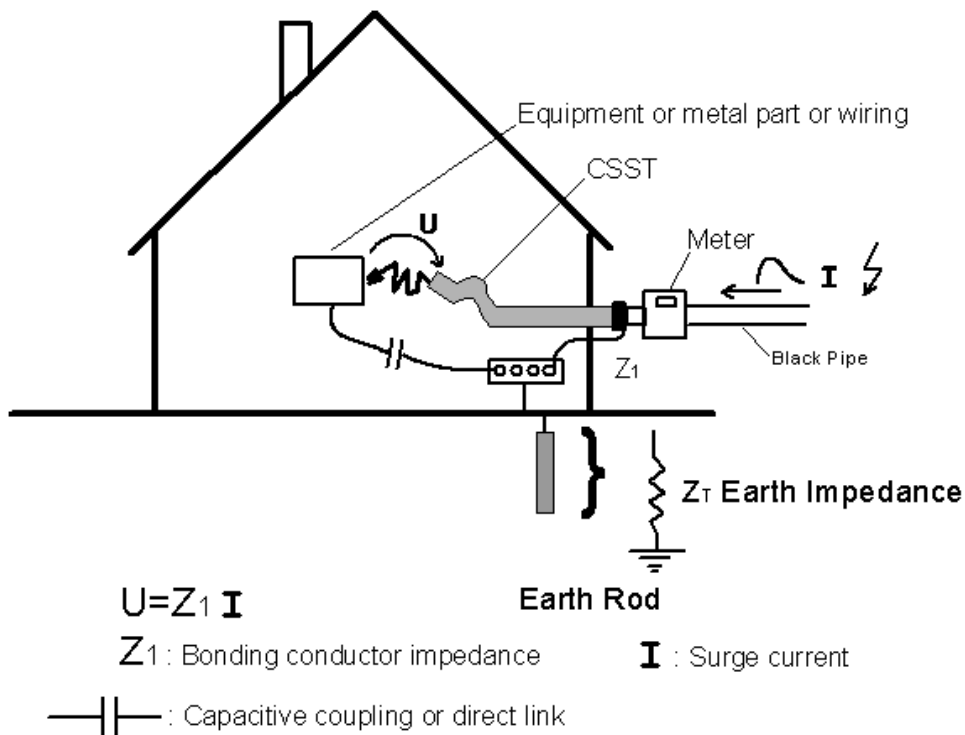
Scenario a)

An example of such a scenario can be found in case A3.27.

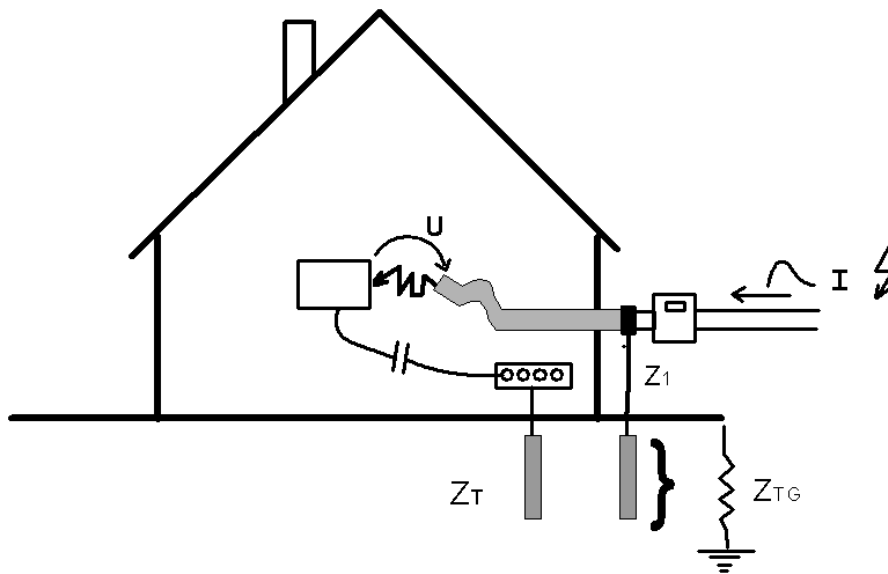
Scenario b)

An example of such a scenario can be found in case A3.11.

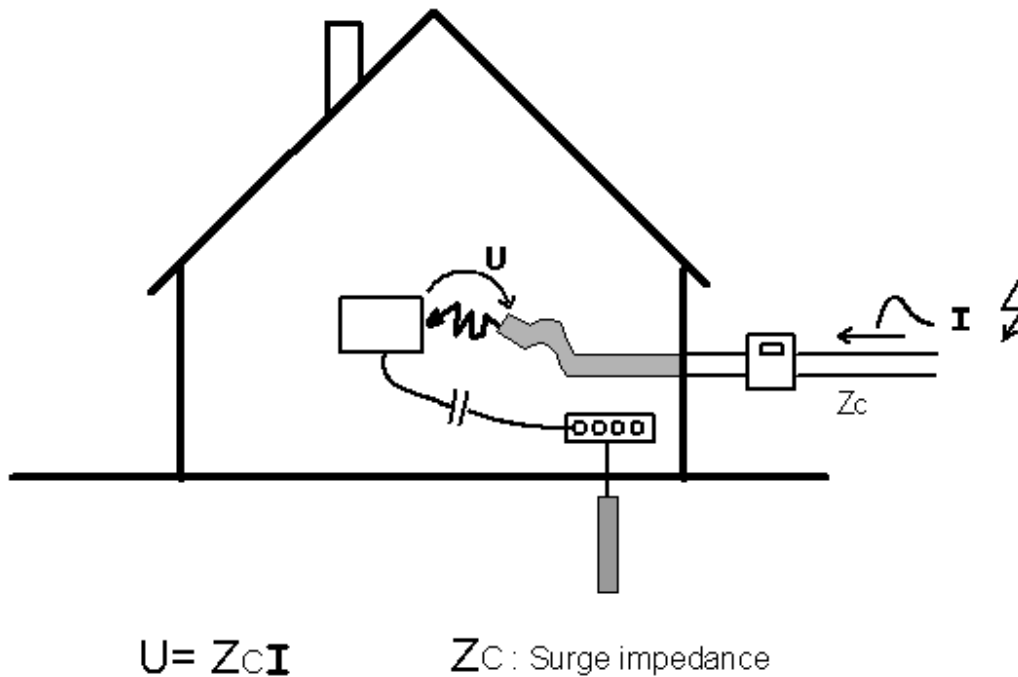
Scenario c)

Scenario c is similar to a) and b), but in this case there is no CSST bonding at all. We don't know at this stage what the surge impedance Z_c of the CSST may be, but if

An example of such a scenario can be found in case A3.13.

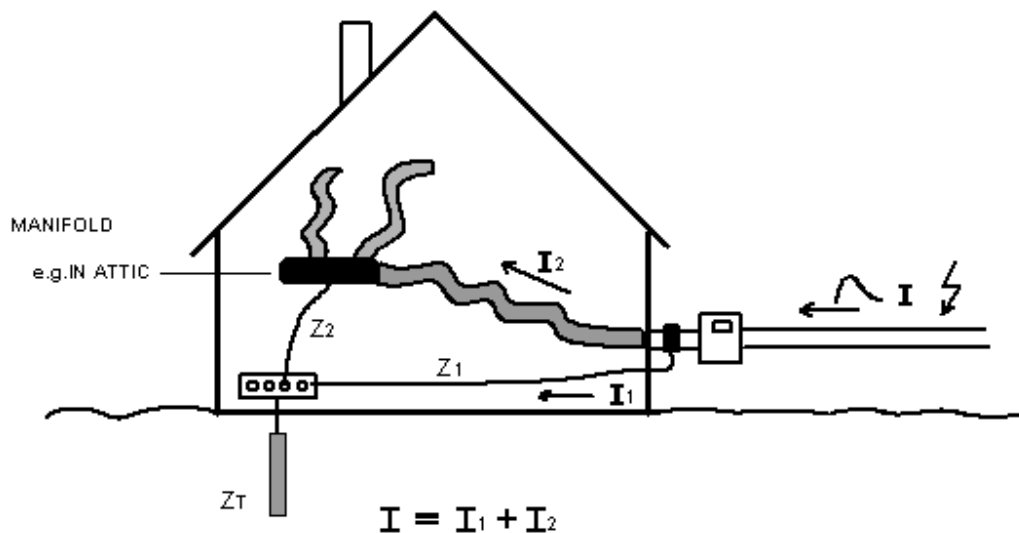
Scenario e) is based on scenario a), but another bonding conductor exists elsewhere in the installation (in the above figure, the additional bonding is at the manifold; this has been seen in some real cases).

An example of such a scenario can possibly be found in case A3.26.

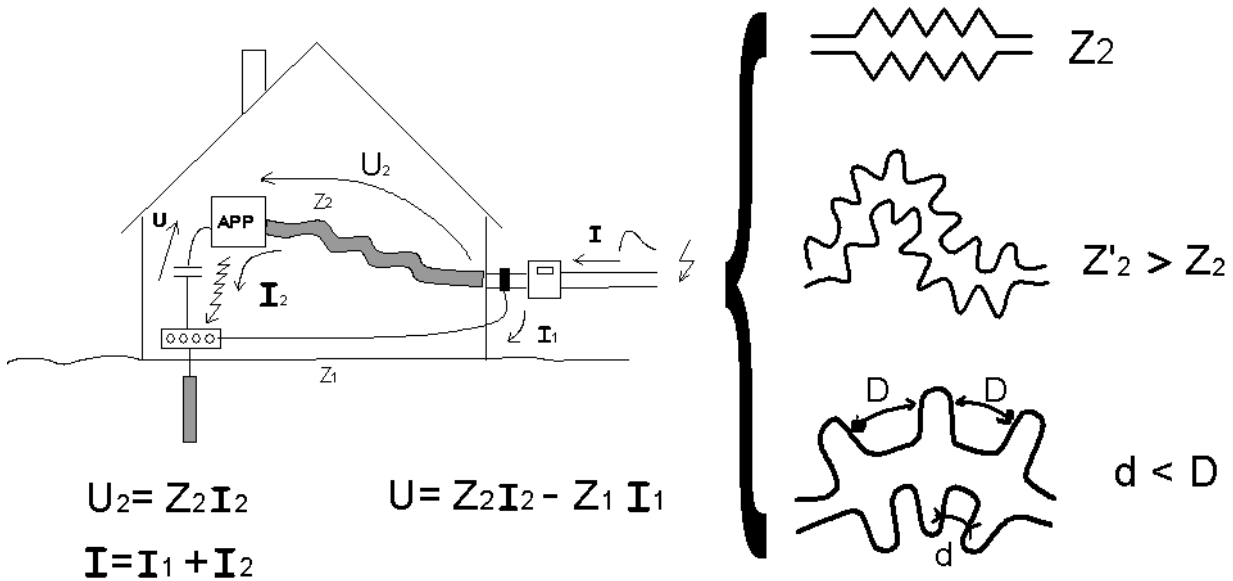
Scenario g)

This scenario emphasizes the effect of the CSST impedance. It is based on scenario e). Whatever the inductance Z_2 of CSST may be, it is clear that the impedance will be slightly more when a bend exists (Z'_2). **Tests to determine CSST impedance should incorporate maximum bending radii as given in technical brochures.**

An example of holes with no metal part in the vicinity can be found in case A3.14.

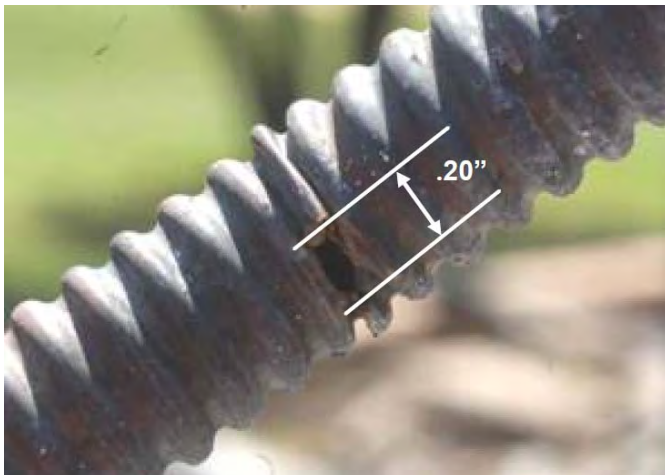
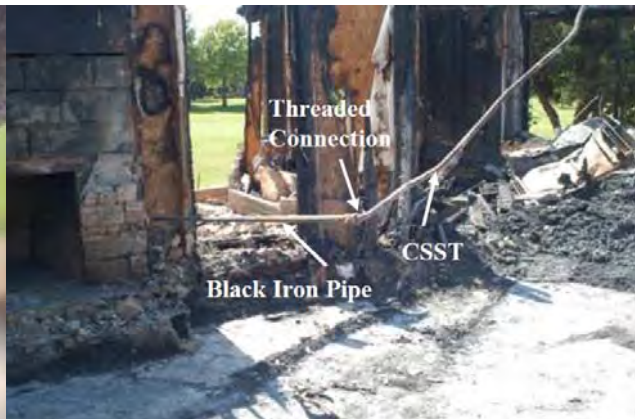
The fire occurred in (construction not finished) a 2 story house, and plumbed with approximately 95% black pipe. Two runs of CSST, each serving a fireplace, comprised the CSST piping in the house. A perforation with its major axis measuring approximately 200 mils was found in one run of the CSST. An interview with a neighbor confirmed that the audible and visual components of the strike were sensed simultaneously. A positive lightning report was obtained, showing 11 strikes within 0.5 mile. Regrettably, the house was razed before the investigation was complete.

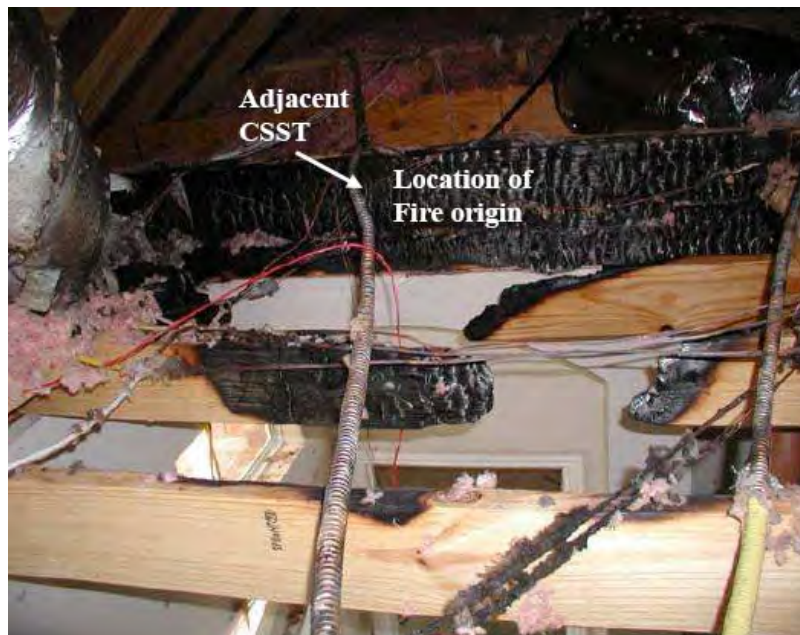
The fire occurred within the attic space of a home, which included several runs of CSST. The CSST runs went to a fireplace, furnace, range, and water heater. During a lightning storm, the CSST run serving the fireplace leaked and the resultant fire then destroyed a section of the attic. A perforation measuring 95 mils along its major diameter was found in the pipe. A lightning report showed that there were approximately 5 strikes within 0.3 mile of the house. The fire was contained within the attic, but subjected the house to extensive smoke damage.

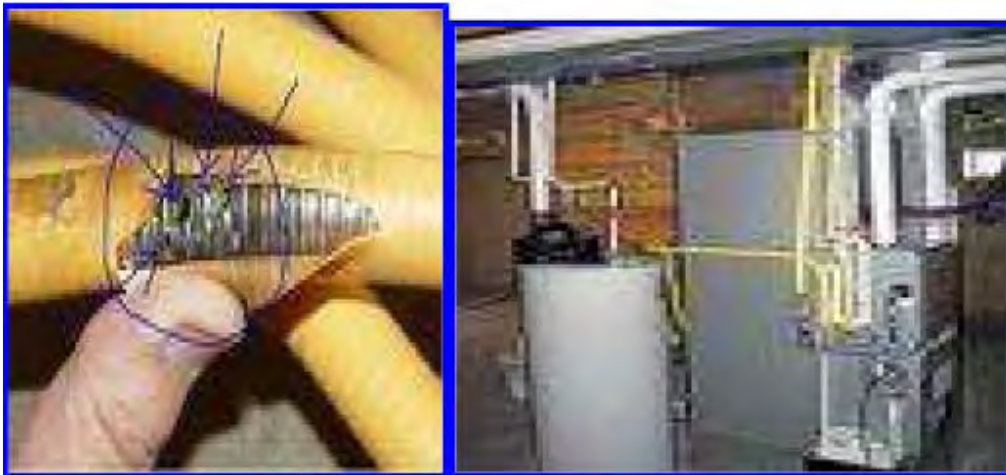
Note: Pictures are taken from another Indiana article. They may not relate to the same case.

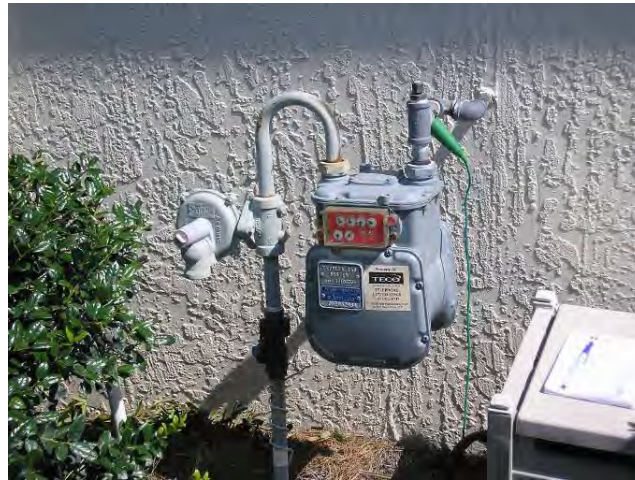
Impedance Test Point for Incoming Gas Line

Grounding system impedance measurements were made from the incoming gas line (see the figure below) and from the ground rod for the power service which is used as the ground reference point for the manifold.

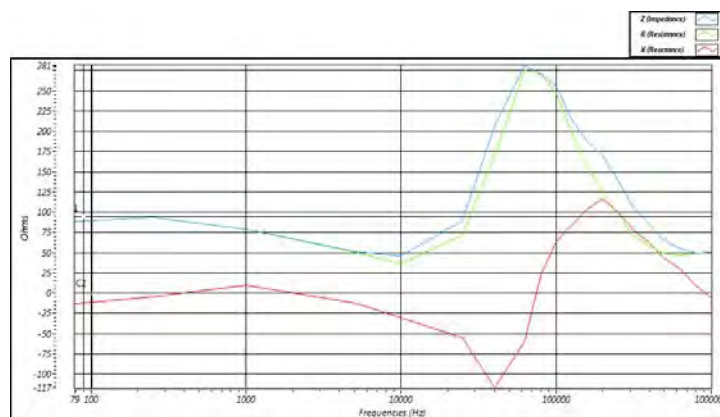
Impedance versus Frequency for Gas Line at Service Entry Point for the second case investigated at the Villages

The low frequency value is found to be approximately 89 ohms. The average high frequency impedance of the gas line at the service entrance was found to be 148.8 ohms; a significant capacitive effect at frequencies above 100 kHz which dropped the impedance at 1MHz to 49.6 ohms.

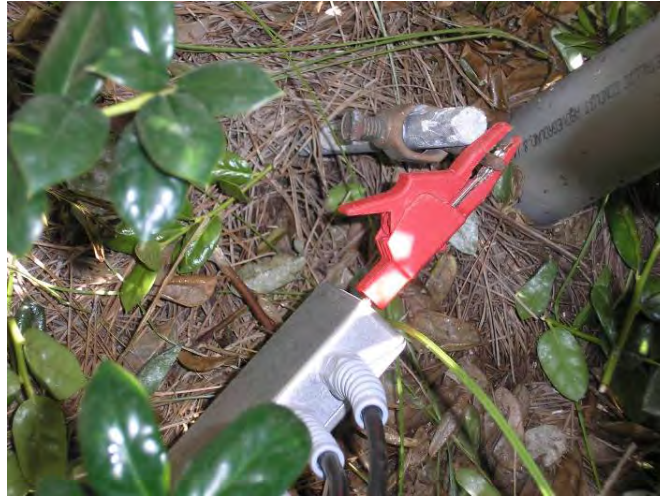
The impedance versus frequency graph for the grounding electrode measured at the test point shown in the figure below was seen to exhibit characteristics of what would be expected for a driven rod at low frequencies starting at 102 ohms and dropping to 52.8 ohms at 5 kHz. Average high frequency impedance is 111 ohms.

Grounding Electrode for Electrical Service and Manifold Ground Reference

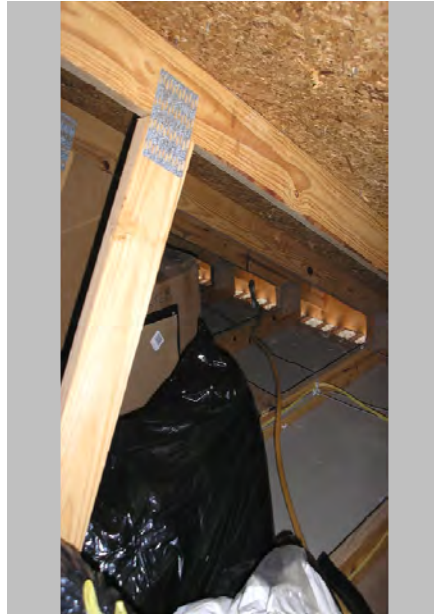
Routing of Incoming CSST Piping

Electrical testing was performed on 3 September, 2010. For Case 1, identified as receiving a direct strike, it is unclear as to whether there was an eyewitness to the event but the homeowner was home at the time and indicated he heard experienced very loud and close thunder. The NFIRS report for the incident indicated that firefighters responding to a resulting fire call found a hole in the ridge vent of approximately 2 inches by 2 inches. No StrikeFax was obtained for this incident. The result of the event was small fires in the attic above the garage and in the master bathroom ceiling. In both these areas, NFIRS indicated the fire resulted in a 3-inch by 3-inch burned area with indication of the presence of a gas line with plastic coating melted in the location above the garage. No such indication was noted for the fire in the master bathroom ceiling. A week after the event a contractor working in the attic smelled gas and upon investigation found that the CSST line adjacent to the hot water heater vent was damaged. The figure above forwards a picture of the burned area and electrically-isolated hot water heater vent showing the repaired CSST piping. The damaged section of piping was removed, spliced as shown, and supported above the hot water heater vent. The incoming gas service is municipal and metered, enters the structure at the meter and rises to the attic area using galvanized piping. The transition to CSST is made at the entry point to the attic. The CSST coursing from the transition point to the manifold runs across and in close proximity to electrical wiring in the attic. The figure below shows the installation of the manifold and the solid #6 AWG copper wire used to ground the manifold through the electrical service ground rod. This appeared to be a common practice here, or at least it was a consistent technique found at the locations visited as a part of this survey. As you can see from this series of photos, the failure point in the CSST piping in Case 1 was in the section of CSST on the source side of the manifold and prior to the grounding of the CSST.

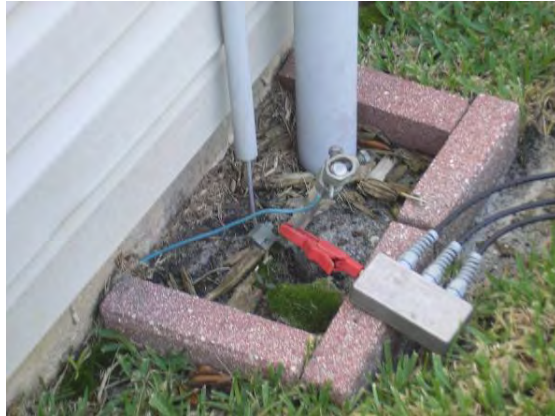
Grounding Electrode Test Point Configuration

High frequency grounding impedance measurements were made on the electrical service entrance grounding electrode and on the customer side of the gas meter. The grounding electrode test point shown in the figure below was found to be a good lightning protection ground given the criteria used by the test equipment used to make the measurement. The grounding electrode exhibited an average high frequency impedance of 38.3 ohms. The test results for the gas entry point at the customer side of the meter indicate an average high frequency impedance of the gas line at the service entrance was found 105.8 ohms; much higher than the grounding electrode average of 38.3 ohms.

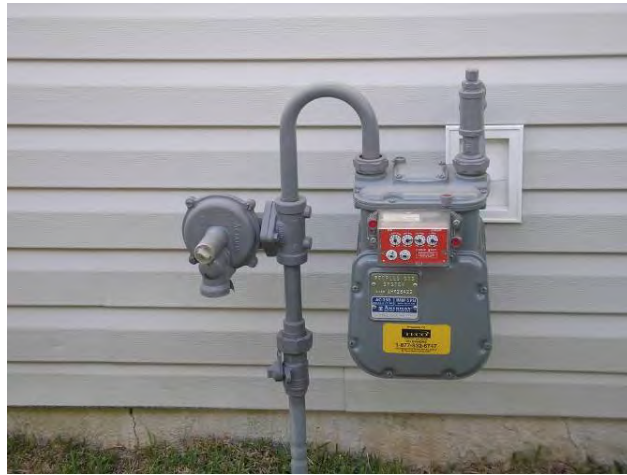
Gas Service Entry Point

The figure below shows the relative location between the service entrances for the phone, electrical power, and gas. There was no visual evidence of an external bond between the gas service entry point and the electrical service ground.
